SERVICE BULLETIN

| Classification: BT02-031 | Reference: NTB02-122 | Date: December 11, 2002 |

2003 350Z; INTERIOR SQUEAK AND RATTLE REPAIR

APPLIED VEHICLE: 2003 350Z (Z33)

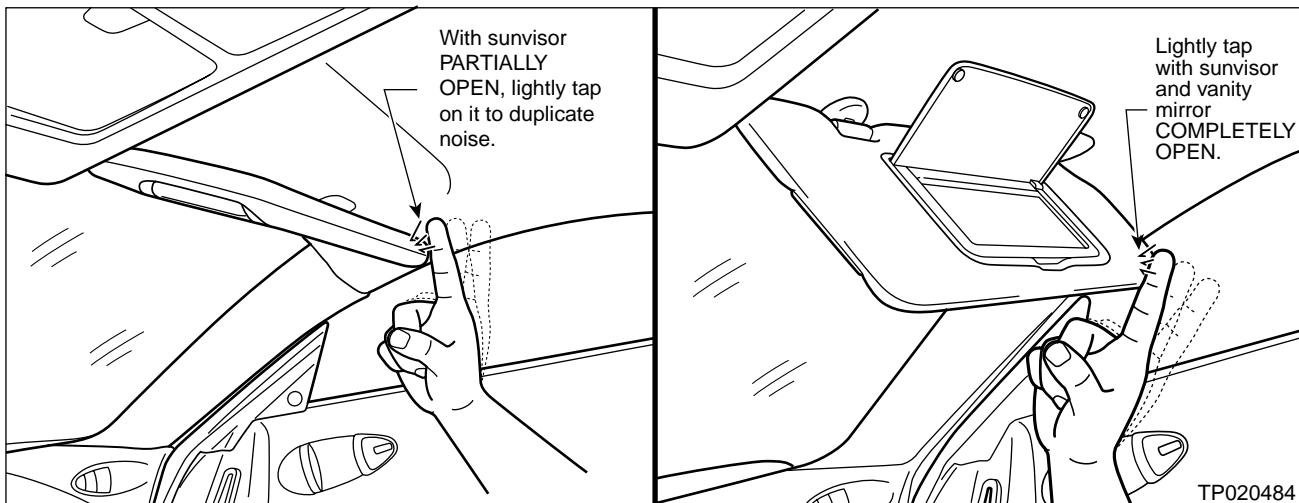
1) Light “wine glass ping”/high-frequency metallic noise from the center upper windshield of vehicle.

1. With the sunvisor in the PARTIALLY OPEN position, lightly tap on the sunvisor to duplicate the noise (see Figure 1A).
2. With the sunvisor and vanity mirror in the COMPLETELY OPEN position (with the vanity mirror light turned “on”), lightly tap on the sunvisor again (see Figure 1B). If the noise is no longer present, proceed to the Repair section, below.

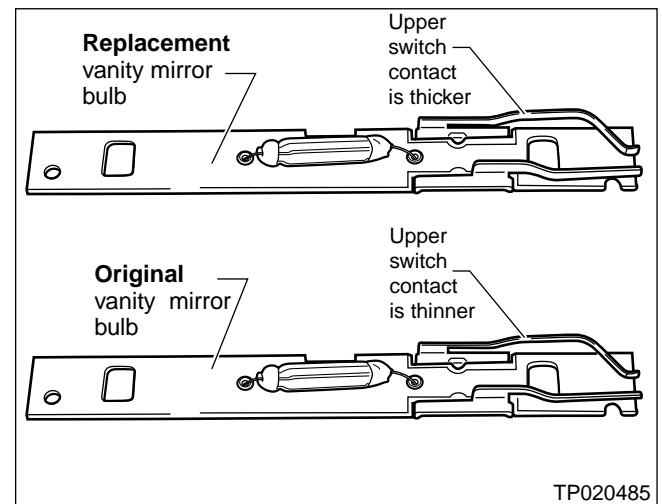
Figure 3

NOTE: The upper switch contact has been increased in thickness on the replacement bulb. See Figure 3.

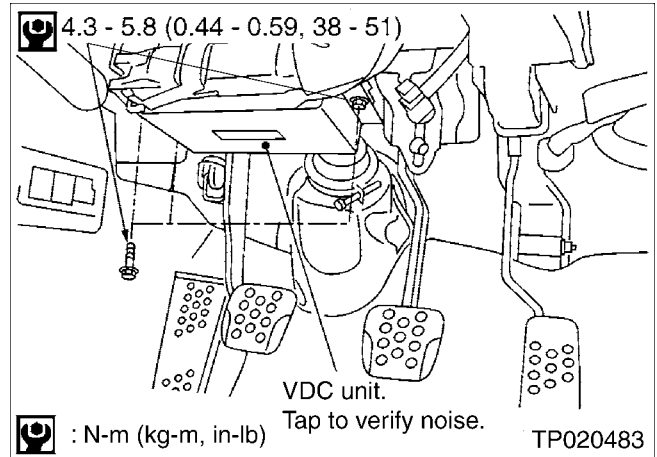
2) Light metallic rattle from lower dash board area, between Vehicle Dynamic Control (VDC) unit switch and steering column.

This noise may be caused by loose VDC unit attaching bolts.

1. Remove the driver-side lower instrument panel. Refer to IP-11, INSTRUMENT PANEL ASSEMBLY.
2. Tap the VDC unit to verify if noise occurs (see Figure 4).
3. Examine the VDC unit bolts for looseness (see Figure 4).
4. Tighten the bolts to 4.3 - 5.8 N-m (0.44 – 0.59 kg-m, 38 - 51 in-lb). See Figure 4

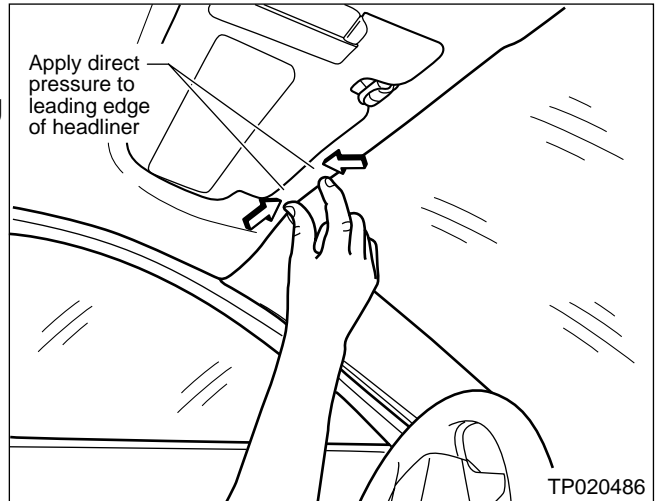
Figure 1

1) Light tapping noise from upper right-hand or left-hand side of vehicle.

While on a test drive, this noise may be changed (stops or gets weaker) by applying direct pressure to the leading edge of the headliner, where it meets the windshield and A-pillar (see Figure 1).

This noise may be caused by the front edge of the headliner (near top of A-pillar) tapping against the windshield. The headliner may not have enough clearance at the windshield.

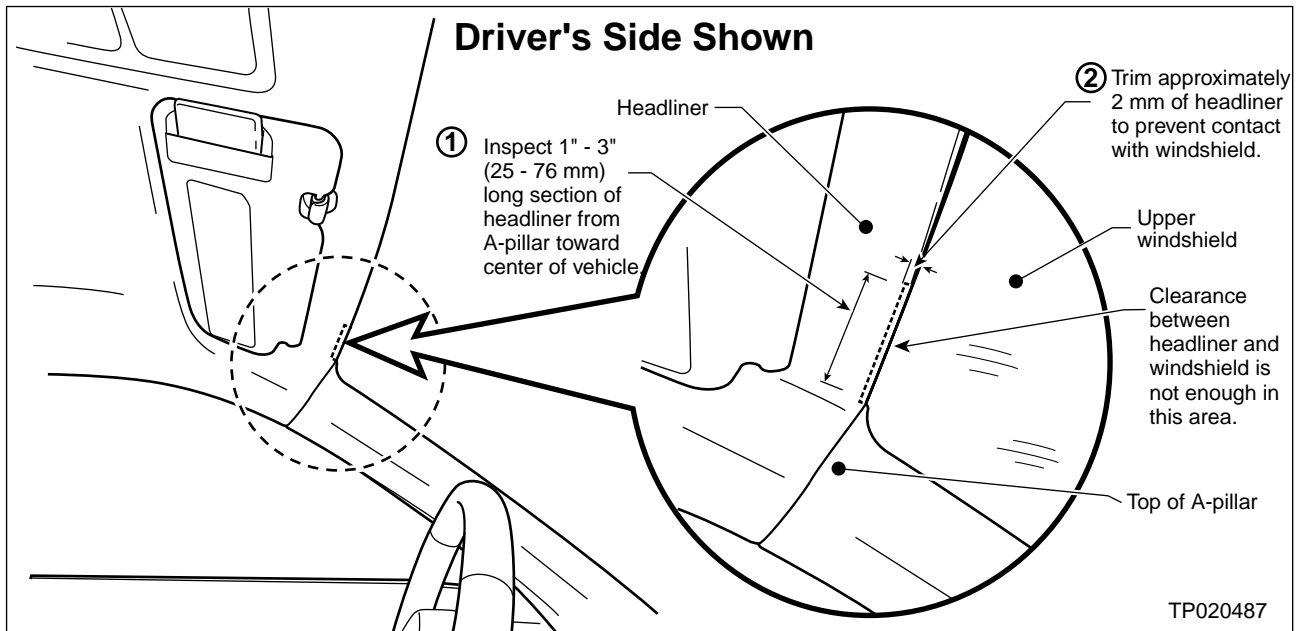
Figure 2

Inspect 1" - 3" (25 - 76 mm) long section of the headliner from the A-pillar toward the center of the vehicle. Check to see if there is enough clearance between the headliner and the windshield (see Figure 2).

If there is not enough clearance between headliner and windshield, trim approximately 2 mm of headliner, where needed (see Figure 2).

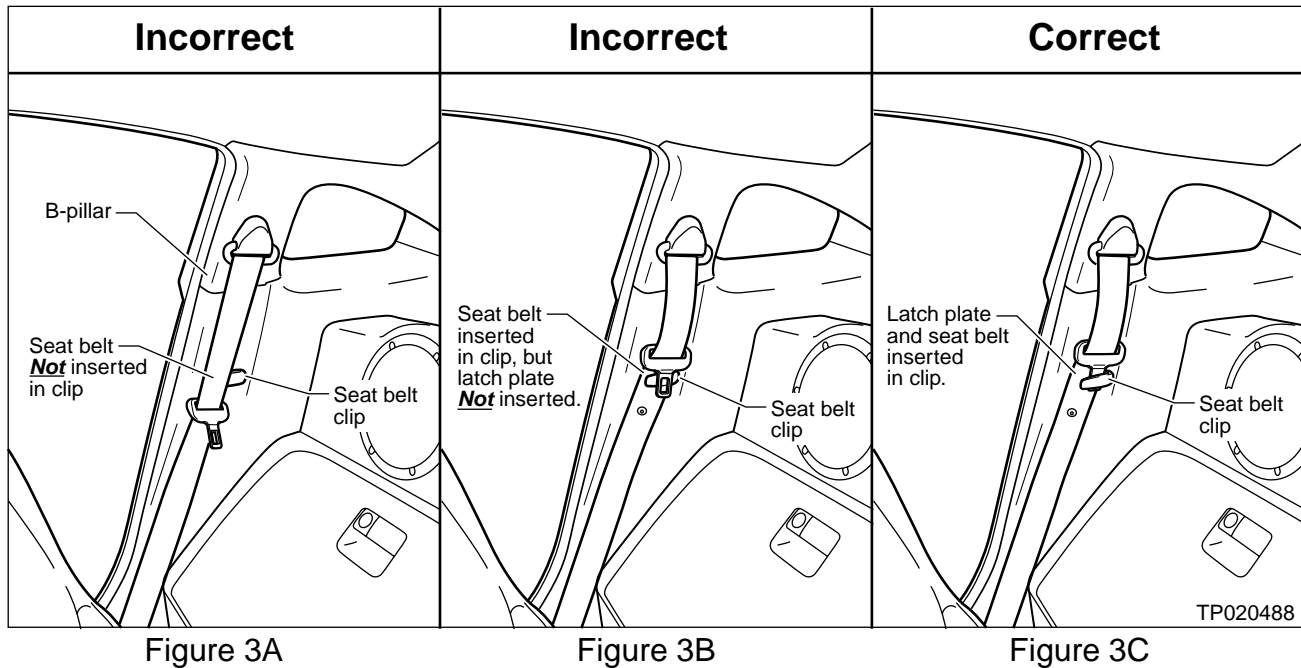
2) Hollow rattle from passenger side of vehicle.

This noise may be caused by contact between the passenger-side seat belt latch plate and the B-pillar.

NOTE: If the seat belt and latch plate **are not completely and properly inserted into the seat belt clip**, the rattle will not be eliminated. See Figures 3A and 3B for examples of incorrectly inserted seat belt/latch plate.

1. Examine the passenger-side seat belt to see how it is secured.
2. Insert both the latch plate **and** the seat belt into the seat belt clip. This is located on the passenger-side B-pillar (see Figure 3C).
