BT09-079
 NTB10-010
 January 19, 2010

2009 370Z; SEAT POPPING NOISE/SLIGHT MOVEMENT FROM FRONT RIGHT SEAT CORNER

APPLIED VEHICLE: 2009 370Z (Z34) Left Side Manual Seat ONLY

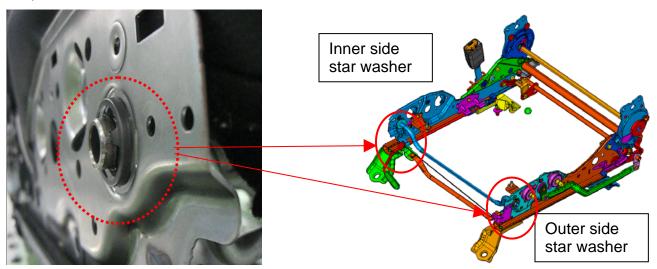
Figure 1

NOTE: Both the inner side AND outer side star washer being replaced in this procedure is shown below.
